Subject: Clean Water Act Compliance Evaluation Inspection Report

**CWA COMPLIANCE EVALUATION INSPECTION REPORT
U.S. ENVIRONMENTAL PROTECTION AGENCY, REGION 5**

Facility: Kinnard Farms, Inc.
E2675 County Road S
Casco, WI 54205

NPDES Permit Number: WI-0059536

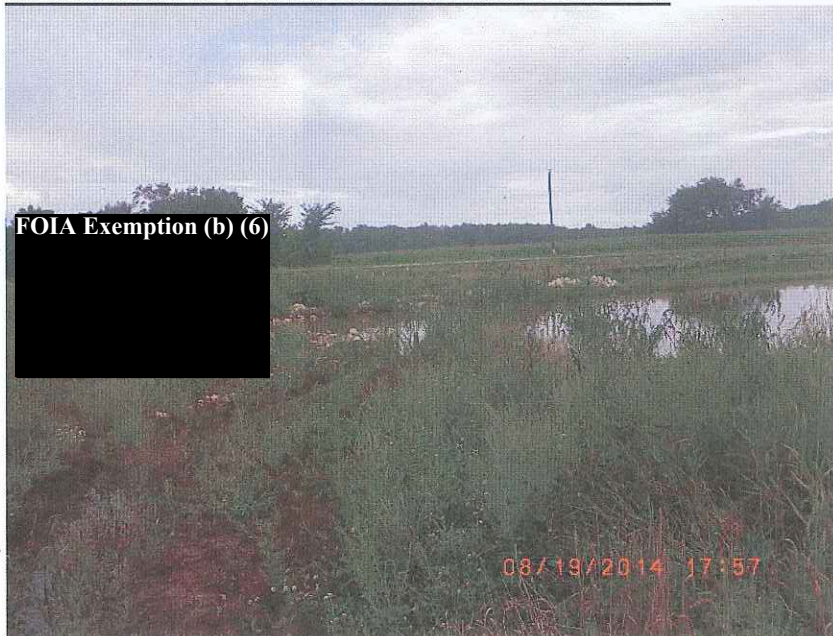
IMGP1351

After the first flush is collected, the process wastewater would flow north into the VTA for the treatment of process wastewater. Process wastewater in the VTA would flow north through the VTA and outlet at the northwest end of VTA into a culvert under Robin Lane (Attachment 2: IMG1351-IMG1356). The discharge would flow north to an intermittent unnamed tributary of Casco Creek. The facility was collecting all process wastewater from the silage pad at the time of the inspection.

Description: Water from the vegetated treatment area (VTA) outlets to the north under Robin Lane. Water would continue north to an intermittent unnamed tributary of Casco Creek.

Location: North end of VTA.

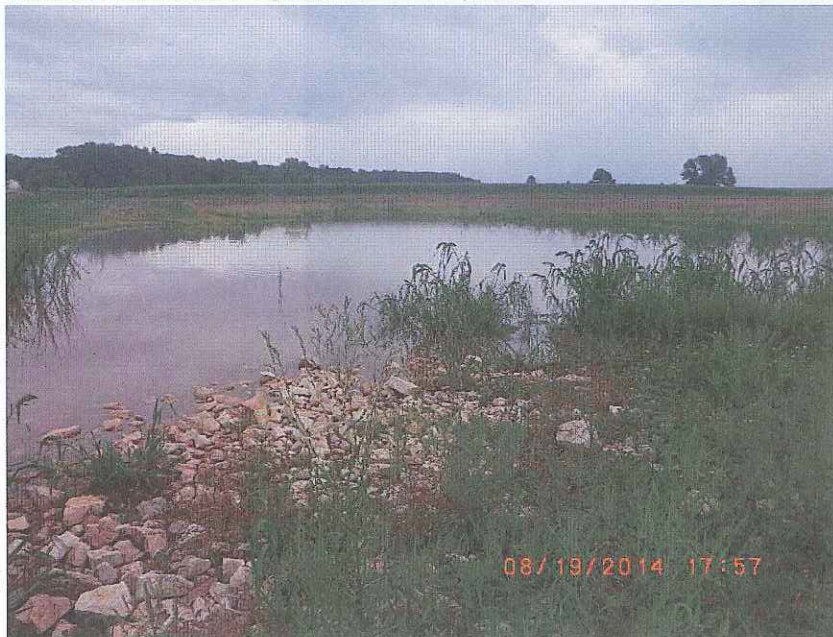
IMGP1352

Description: Water in the VTA.

Location: North end of VTA.

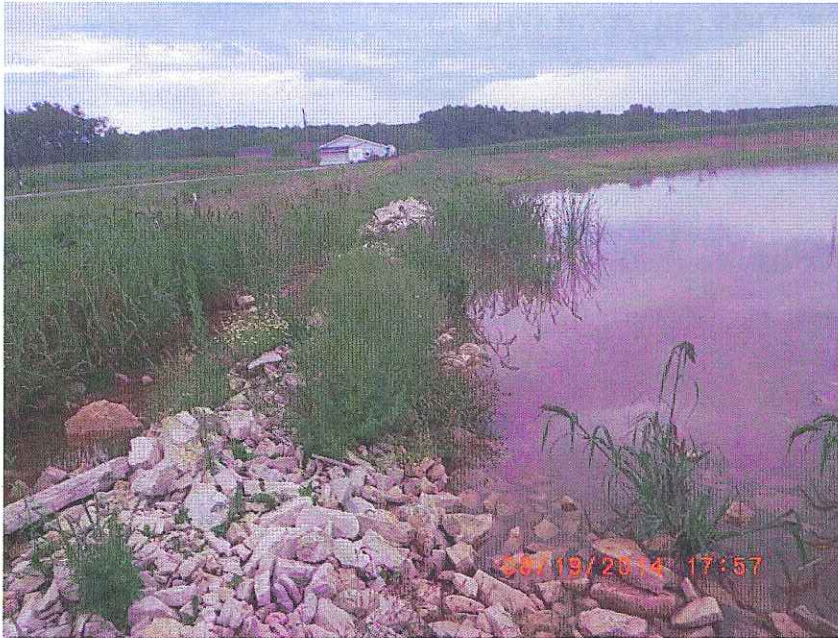
IMGP1353

Description: Water in the VTA.

Location: North end of VTA.

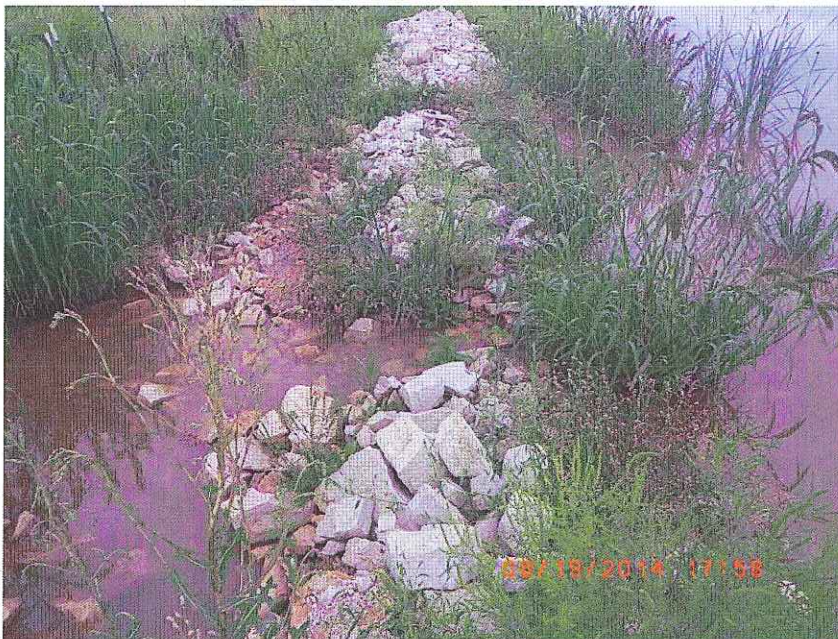
1: IMGP1354

Description: Water from the VTA flows north under Robin Lane.

Location: North end of VTA.

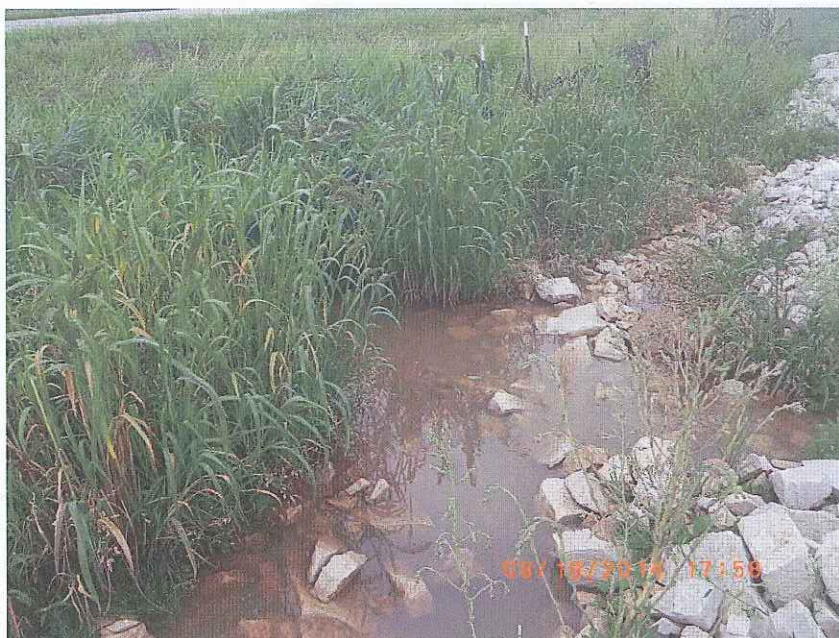
2: IMGP1355

Description: Water from the VTA flows north under Robin Lane.

Location: North end of VTA.

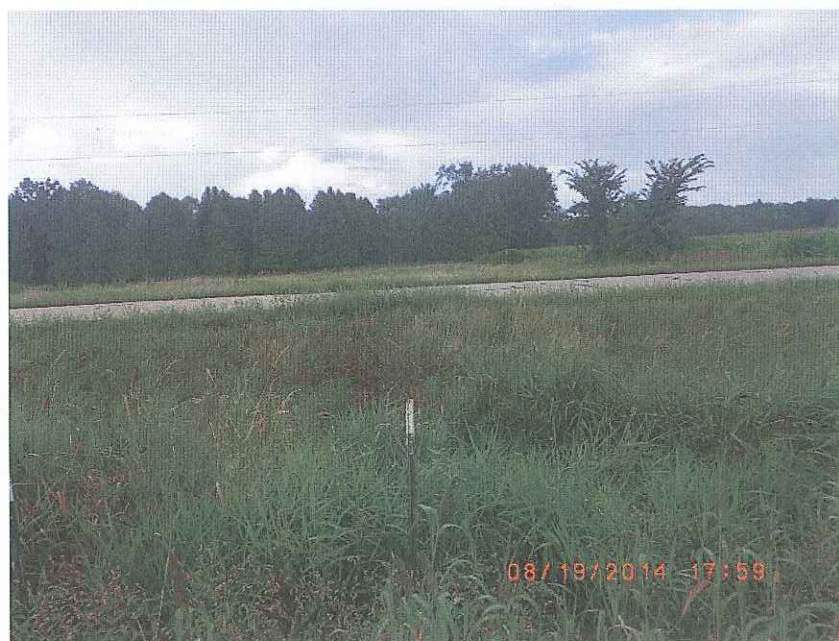
3: IMGP1356

Description: Water from the VTA flows north under Robin Lane.

Location: North end of VTA.

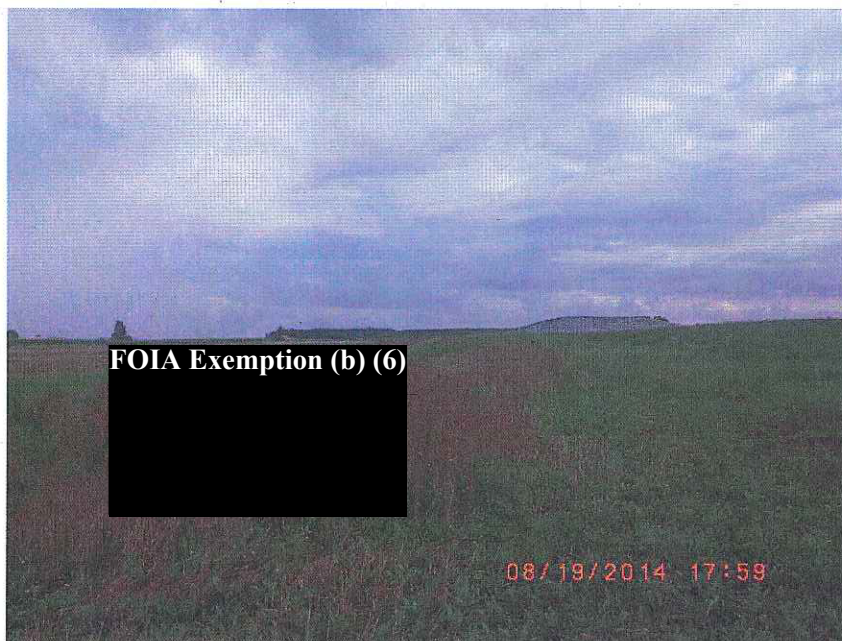
4: IMGP1357

Description: Area west of VTA.

Location: West of VTA

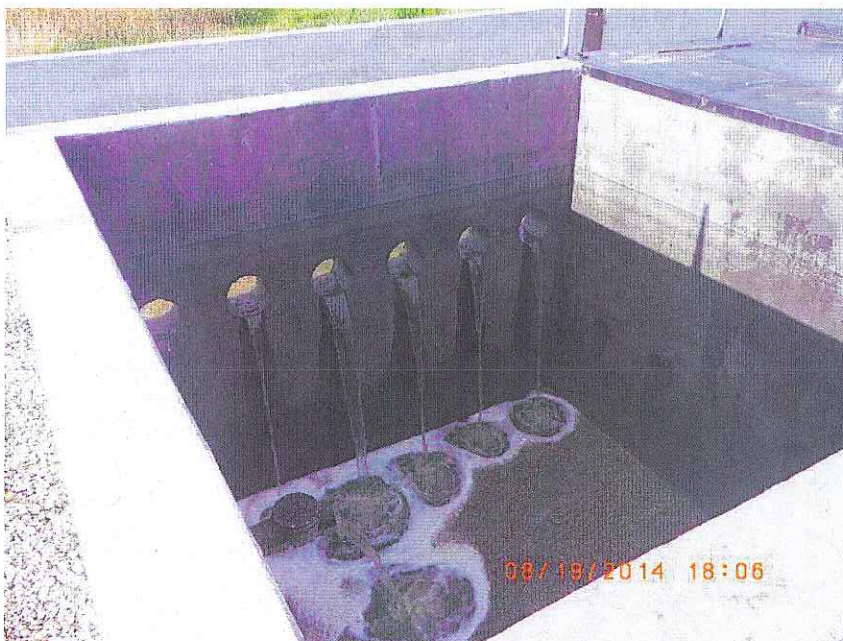
5: IMGP1358

Description: Collection pit for wastewater generated on the silage pad.

Location: South end of VTA.

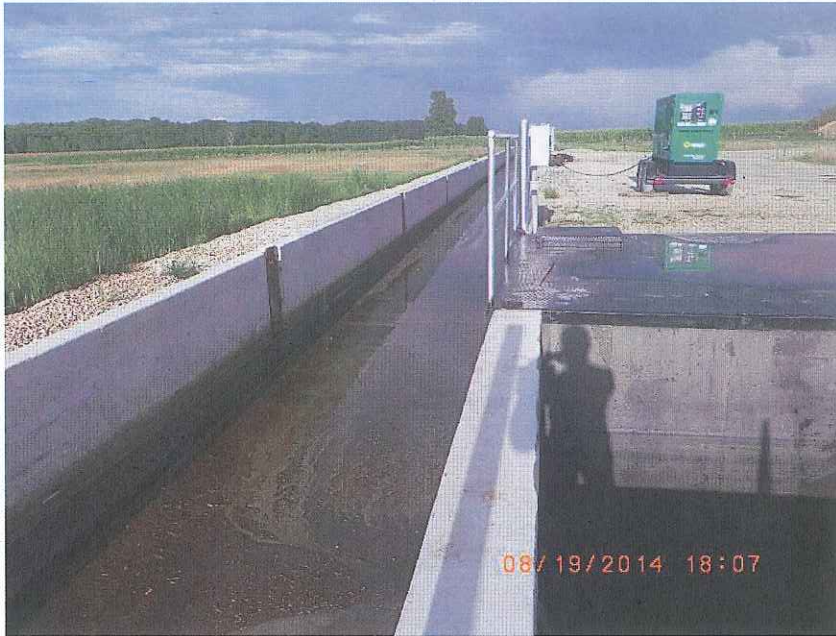
6: IMGP1359

Description: The concrete structure spreads out wastewater along the length of the VTA. The outlet structures were closed during the inspection.

Location: South end of VTA

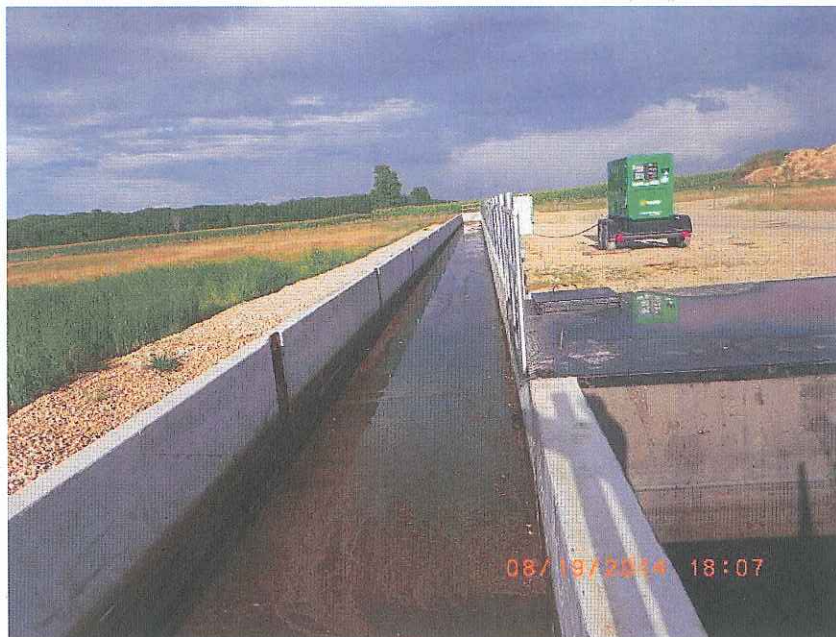
7: IMGP1360

Description: The concrete structure spreads out wastewater along the length of the VTA. The outlet structures were closed during the inspection.

Location: South end of VTA

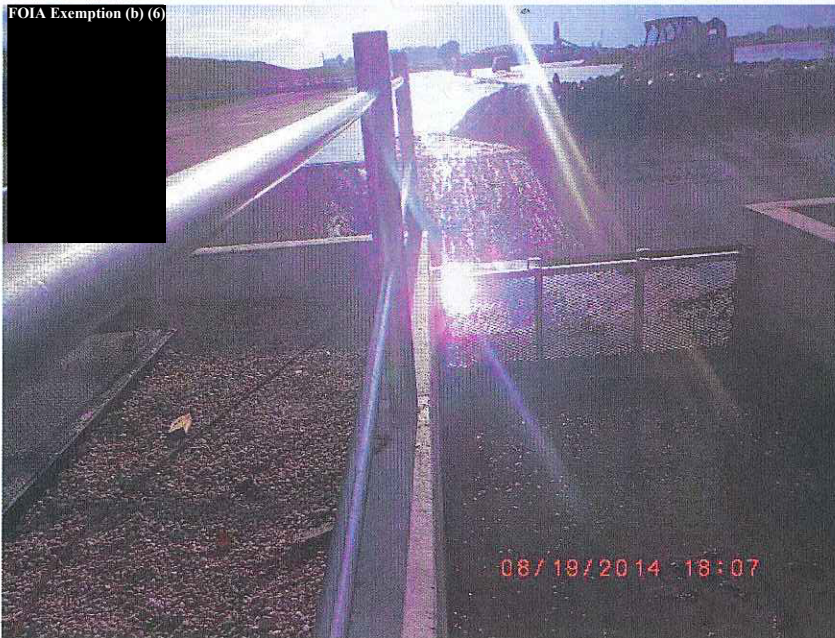
8: IMGP1361

Description: Inlet into the spreader and collection structures.

Location: South end of VTA
